Kampot Cooling

Innovative Technology Solution to Save
Cambodia's World-Famous Pepper

PERFORMANCE ANALYSIS OF INNOVATIVE SOLAR-POWERED COOLING AND IRRIGATION SYSTEM FOR IMPROVING PEPPER FARMS

November, 2025

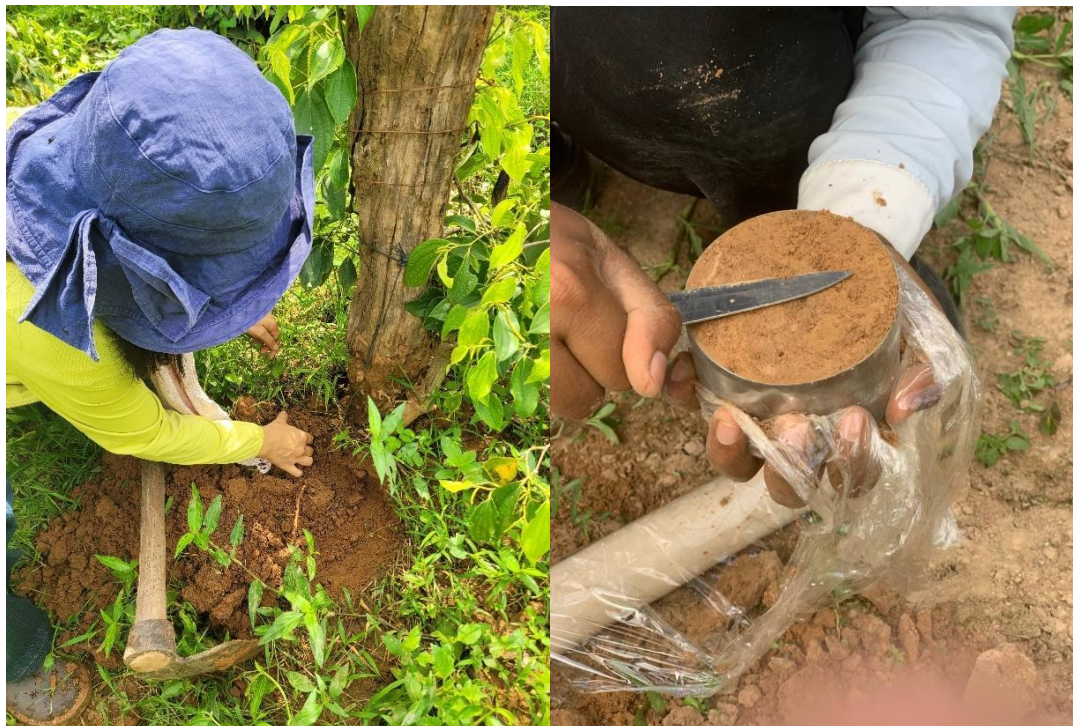
Figure 4. Soil sampling activities

To achieve a comprehensive understanding of the pepper cultivation practices and the impact of the solar-powered cooling systems, various types of relevant data were collected systematically. Soil samples (Figure 4) were taken from two selected Kampot pepper pilot farms, with specific details outlined in Table 2. For each site, two samples were collected from both a test plot and a non-test plot, resulting in a total of four samples across the two farms.

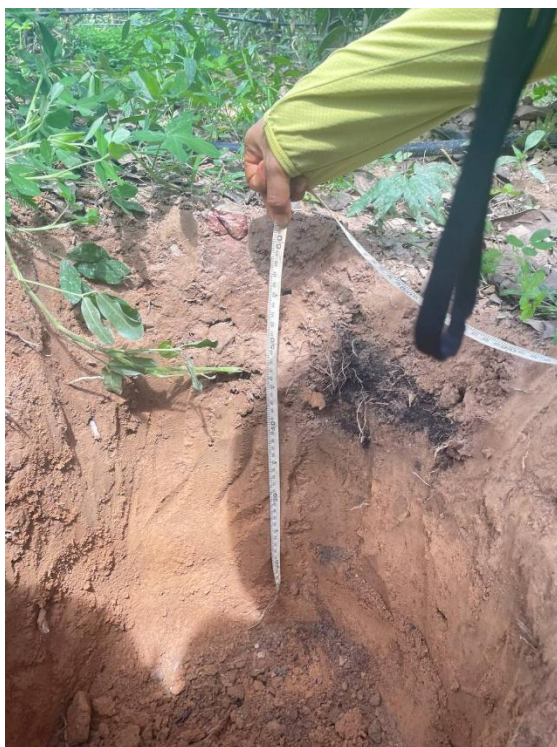
Figure 5. Soil profile at Fair Farm

- **Soil Profile Analysis:** To characterise the soil horizons and properties effectively, a pit measuring 0.5 m x 0.5 m x 0.5 m was excavated on each farm. This allows for sampling at various depths to gain insights into the different layers of the soil and their respective characteristics. Soil profiles of Fair Farm and Reaksa Farm are given in Figure 5 and Figure 6, respectively.

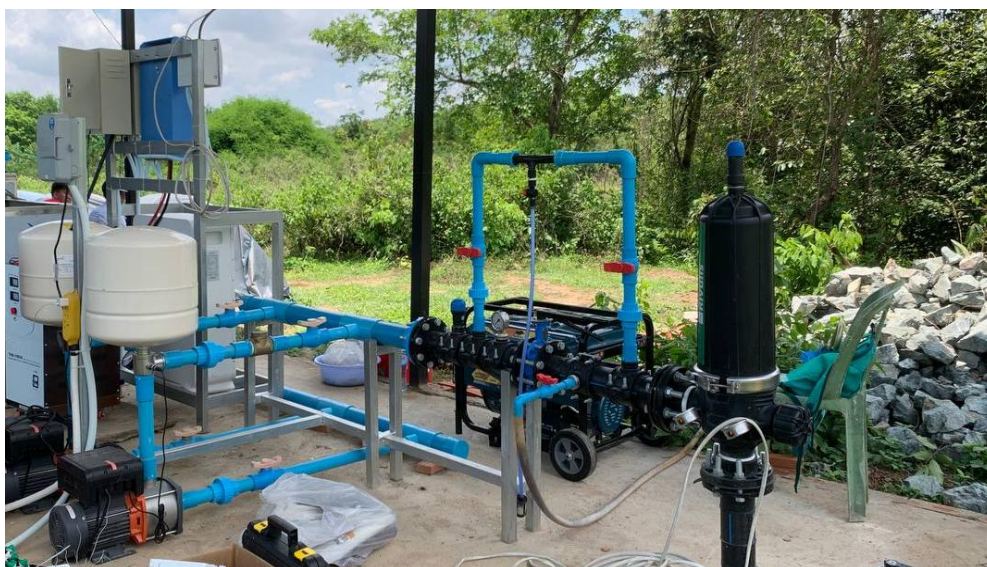
Figure 7. Drip irrigation system at Fair Farm

The two farms have slightly different irrigation management practices. Fair Farm did not record the irrigation used per day or month. During the dry season, they watered the pepper every 2-3 days. Before 2025, manual watering was employed, involving 10 workers and taking 2-3 days to complete one cycle. However, in 2025, an automated drip irrigation system was installed by a local company (see Figure 10), reducing the need for labour to just one person. Currently, there are no specific controlled variable, such as soil humidity or air temperature, to manage the irrigation system. Instead, the dryness of the soil is visually assessed. The installation company recommended irrigating the pepper for 12 minutes each time. The main water source for irrigation is the underground water. However, during the dry season, the water level in the well is significantly low, preventing the farm from pumping at full capacity and adequately irrigating the peppercorn, which has led to some plants dying. Water is pumped by an electric water pump. In the dry season, the farm spends approximately \$200 per month on water pumping, while in the rainy season, the cost drops to about \$125 per month.

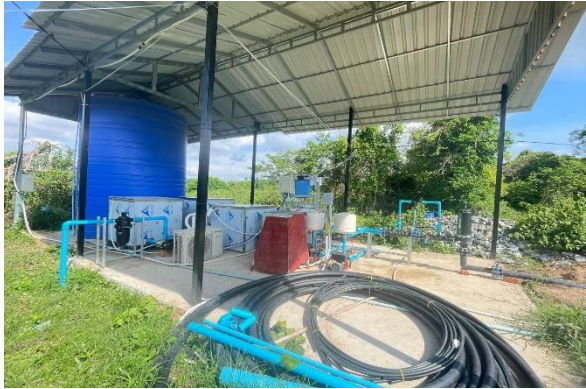
Figure 15. Water tank

Water for the cooling system is sourced from a 20,000-litre storage tank (Figure 20) and is utilised by a 4 horsepower, 3-phase cooling system (Figure 21) designed for agricultural microclimate control. This system features a compressor and refrigerant circuit that circulates refrigerant through copper coils for effective heat exchange, a large finned aluminium condenser paired with a high-capacity fan to dissipate heat, and an integrated electrical and control panel for operation and protection. Its primary application is to supply cooled water for the fogging and spraying system, ensuring that canopy temperatures in pepper farms remain below 35 °C during periods of heat stress.

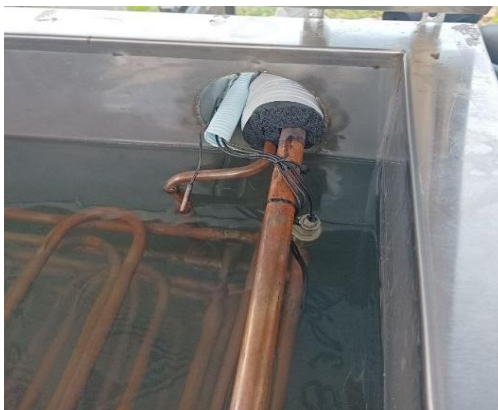
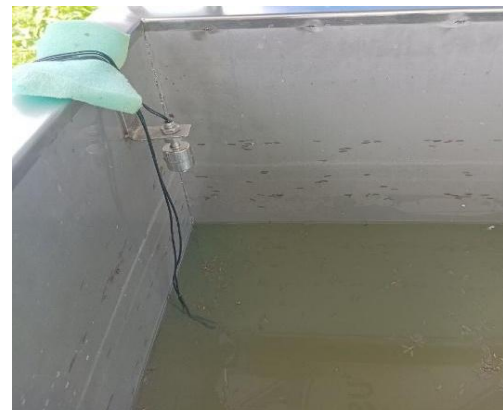
A copper coil heat exchanger, Figure 22 (a), submerged in a stainless-steel water tank (SUS 304), is an integral part of the refrigeration circuit connected to the cooling unit. Made from copper tubing for its high thermal conductivity, the coil circulates refrigerant that absorbs heat from the surrounding water, lowering the water temperature as the refrigerant evaporates and creating a cold-water supply. The water-cooling system operates automatically based on sensor and controller. There are water level sensors, Figure 22 (b), to detect the water level in the tank and temperature sensors to measure the temperature of water.

Figure 22. Heat exchanger of the cooling system (a) and sensor for controlling water temperature (b)

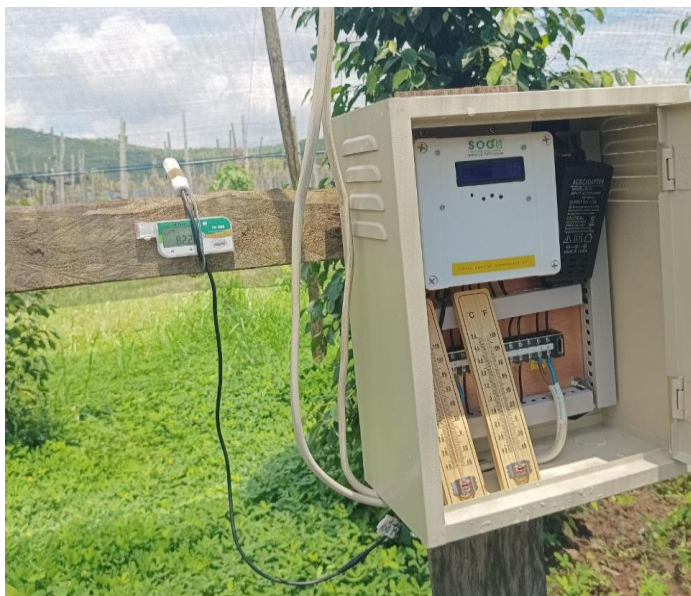
Figure 19. Controller for spraying system

The fogging system is managed by a smart controller (Figure 25) that automates spraying based on temperature thresholds: spraying activates when the temperature reaches 35°C or higher and deactivates when it drops to 32°C or lower. Additionally, temperature and system data are monitored and recorded at 5-second intervals to ensure responsive control.

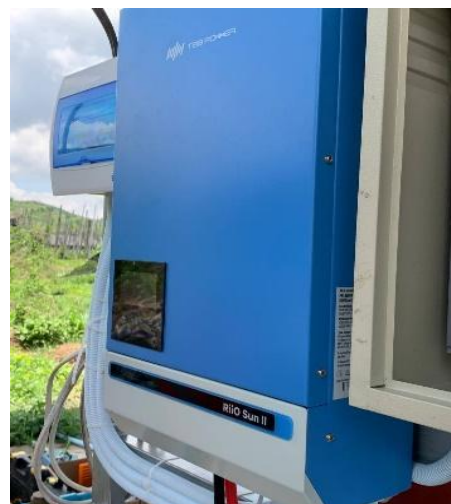
Figure 28. Inverter

For inverter, the RiO Sun II 6KVA all-in-one solar inverter (Figure 28) supports DC input 48V / 150A and provides AC output 230V, 50/60Hz. It also functions as an AC charger (230V input, 50/60Hz, 60A) and solar charger with PV open-circuit voltage 250V, PV input current 40A, and MPPT voltage range 120–240V. Rated DC output is 48V / 100A.

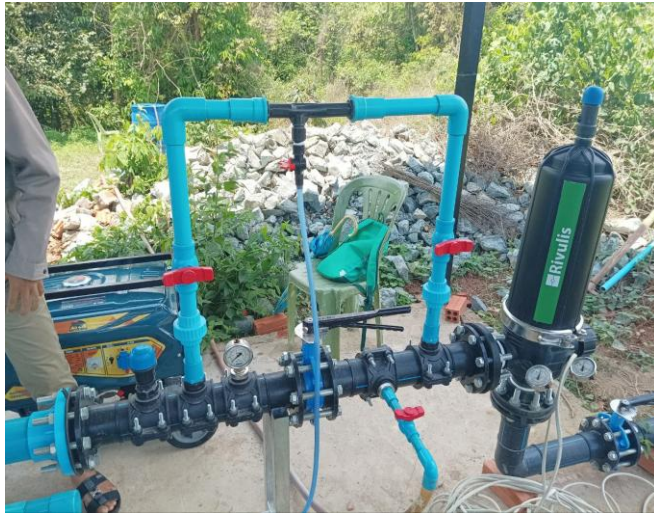
Figure 21. Drip system head unit at Fair Farm

constant pressure, and protect the system from surges, with a maximum working pressure of approximately 10 bar, as indicated on the label. This system is integrated with the drip irrigation head unit, featuring a Rivulis filter for a clean water supply, and is equipped with pressure gauges, valves, and fertigation lines for effective control. It ensures a steady flow to both the drip laterals and the fogger spray system.

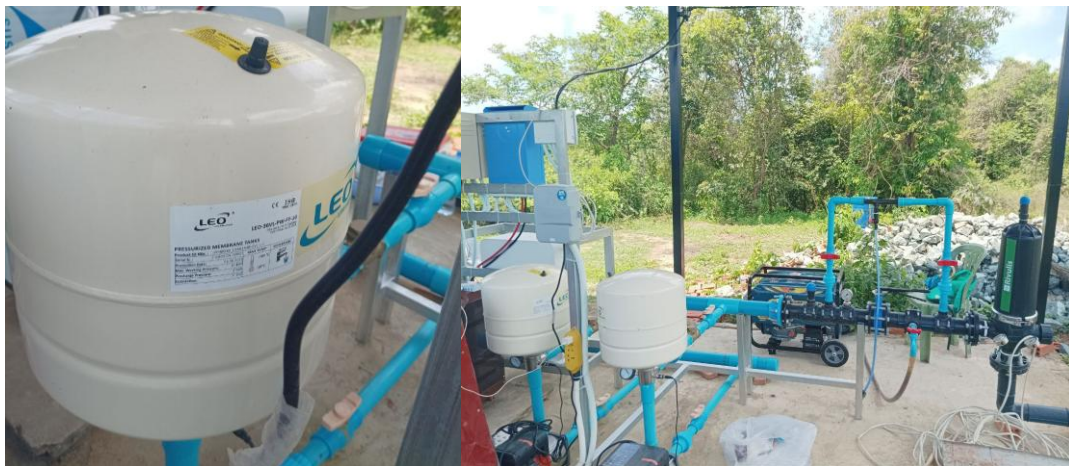
Figure 31. Pump and pressurised system at Fair Farm

The pump and pressurised system (Figure 31) comprise an electric centrifugal pump, visible in the setup, and is coupled with LEO Pressurised Membrane Tanks (36L) to stabilise water pressure. Two LEO membrane tanks are installed to minimise pump cycling, maintain

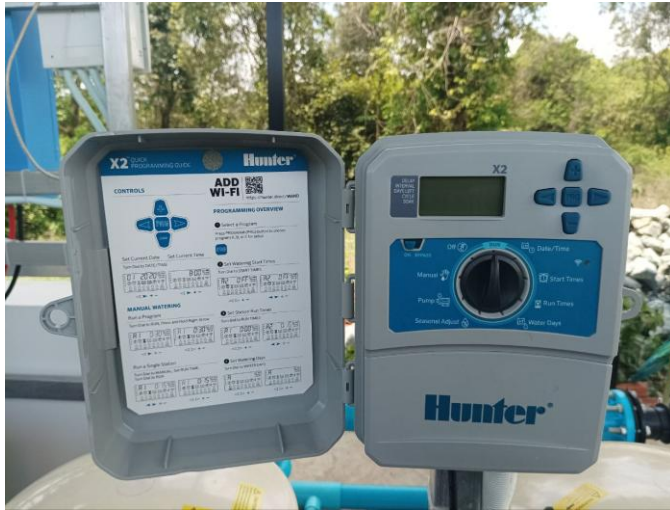
Figure 22. Controller for irrigation system at Fair Farm

The automatic controller (Figure 32), a Hunter X2 model, serves as an irrigation timer with a dial-based programming system and a digital display, allowing for multiple start times and run times per day, along with manual start and seasonal adjustment functions. It features smart capability, being compatible with the Hydrowise Wi-Fi module for potential upgrades enabling remote control via smartphone or PC. Typically, it supports 4 to 14 stations, depending on the model configuration, and operates on standard AC power, providing output for irrigation valves and a pump start relay. This controller is used to manage both drip irrigation and fogger spray systems by scheduling automatic operations based on time or seasonal requirements.

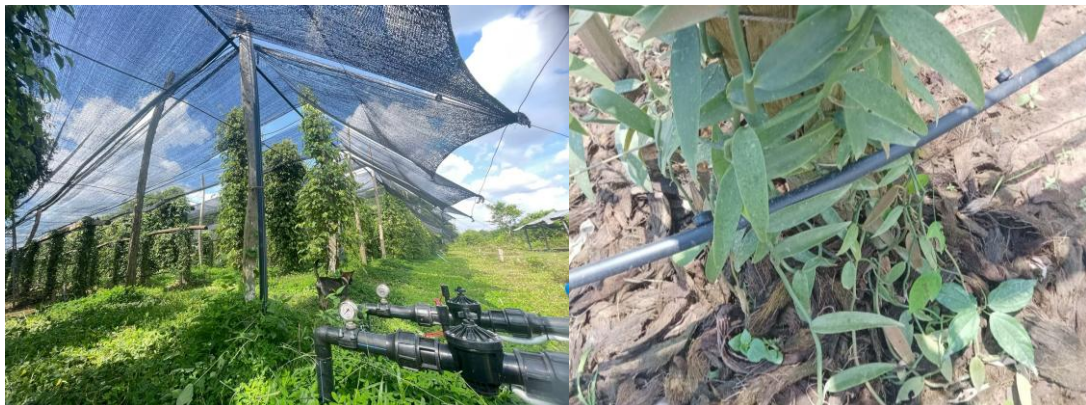
The automatic valve, Figure 33 (a), is a solenoid-controlled irrigation valve made from heavy-duty plastic with reinforced fittings, designed for durability in agricultural environments. It features pressure gauges on both sides to monitor inlet and outlet pressure, ensuring stable operation. This valve automatically opens and closes water flow based on signals from the Hunter X2 irrigation controller or a similar smart controller, maintaining regulated pressure and flow to the drip laterals and fogger systems. Additionally, it can be manually overridden using a red-handled valve for maintenance or emergency control.

The drip lateral, Figure 33 (b), specifications include flexible polyethylene (PE) tubing with a typical diameter of 16 mm, which is standard for farm drip irrigation. The layout runs close to the base of the pepper vines and is secured near the support pole. Integrated or attached button-type emitters deliver water directly to the root zone, ensuring low-pressure, uniform water distribution to individual plants. This setup reduces water loss through evaporation and promotes efficient irrigation, making it particularly optimized for perennial crops like pepper, where precise water delivery at the root zone is essential.

Figure 23. Automatic vale (a) and drip lateral (b) at Fair Farm

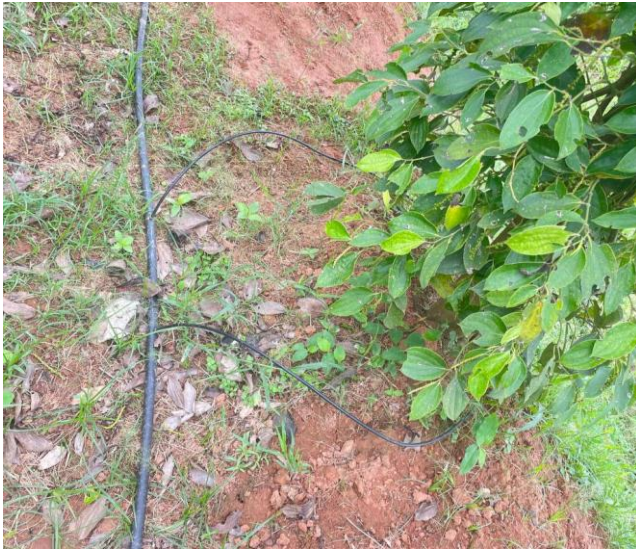
Figure 24. Drip lateral at Reaksa Farm

to button-type drip emitters. This setup ensures low-pressure, localized water delivery directly to the plant root zone, promoting efficient irrigation and minimising water loss.

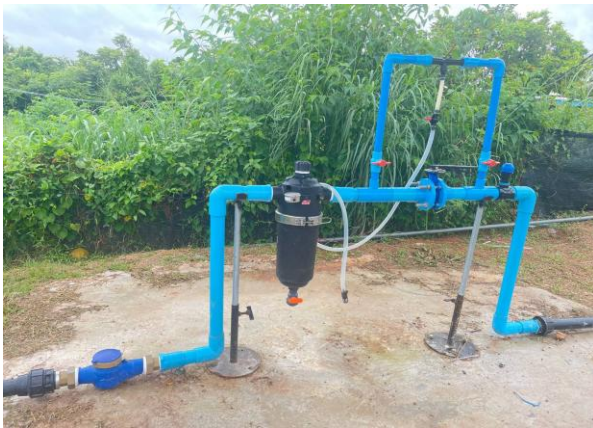
Figure 25. Drip irrigation head unit at Reaksa Farm

The drip irrigation head unit (Figure 35) specification includes key components such as a sand/media filter (black canister) with a pressure gauge, a heavy-duty PVC pipeline manifold (blue, approximately 2–3 inches in diameter), and a fertigation/venturi injector system. This unit filters water to prevent emitter clogging, provides fertigation capability through the venturi injector (white transparent tube), and regulates pressure while distributing water through the mainline to the sub-main drip laterals.

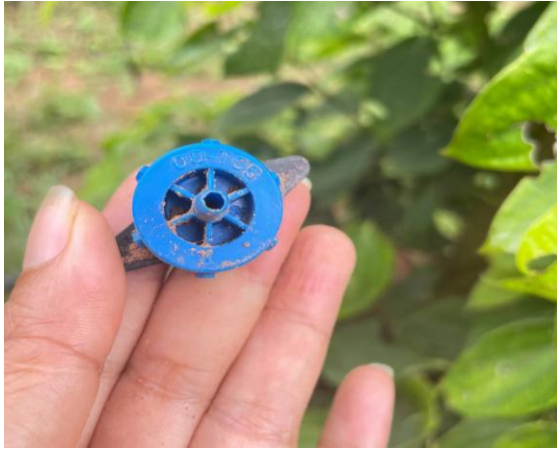
Figure 36. Emitter for drip irrigation system at Reksa Farm

The emitter Figure 36 specification for the drip irrigation system features a button-type drip emitter made from durable, UV-resistant plastic, typically color-coded blue to indicate the flow rate class according to emitter standards. The flow rate ranges from approximately 2 to 8 L/h, depending on the model and water pressure, with the marking "DD-16S" suggesting a 16 L/h pressure-compensating type. It operates within a standard pressure range of 1 to 2 bar (15 to 30 psi) and is designed with a circular outlet that includes multiple cross-slots to regulate and stabilise the flow.

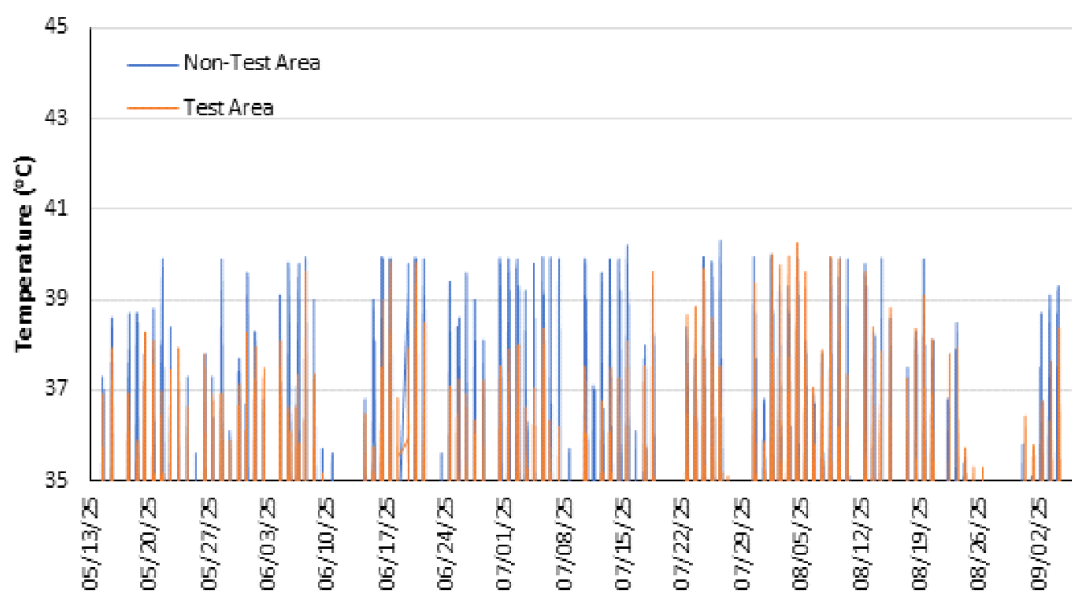
Figure 36. Temperature comparison between non-test area and test area at Fair Farm

The cooling systems at both farms were programmed to activate when temperatures exceeded 35°C. In order to evaluate the performance of these cooling systems at these two farms, the datasets were systematically trimmed. Specifically, any observations where the temperature in the non-test area fell below 35°C were excluded from the analysis. The results of this analysis, which compare the temperatures in the non-test area to those in the test area, are illustrated in Figure 47 for Fair Farm and Figure 48 for Reaksa Farm. The results presented in Table 14 clearly indicate that the temperatures in the test areas were consistently lower than those in the non-test areas across both farms, with a statistically significant difference ($p < 0.001$). Specifically, the average temperature recorded in the non-test area at Fair Farm was 37.12 ($\pm 1.31^\circ\text{C}$), while the average temperature in the test area was significantly lower at 28.95 ($\pm 3.25^\circ\text{C}$), resulting in a notable difference of 8.2°C. Similarly, at Reaksa Farm, the average temperature in the non-test area was measured at 37.16 ($\pm 1.59^\circ\text{C}$), whereas the average temperature in the test area was found to be 29.71 ($\pm 2.96^\circ\text{C}$), leading to a difference of 7.4°C.
